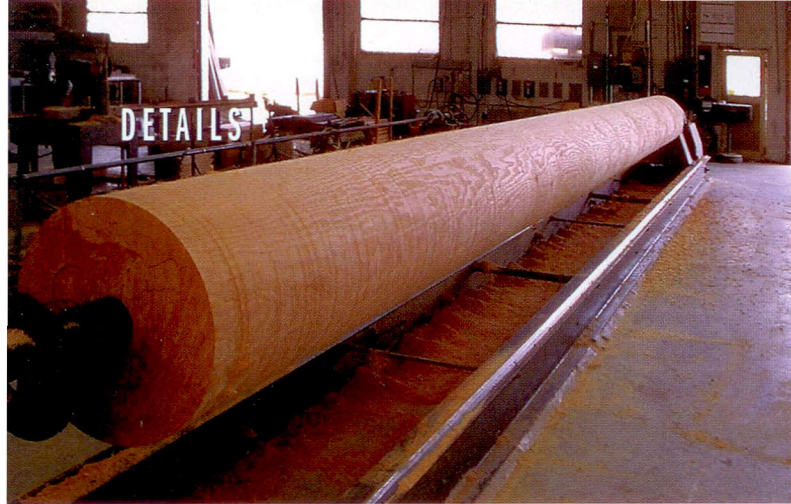
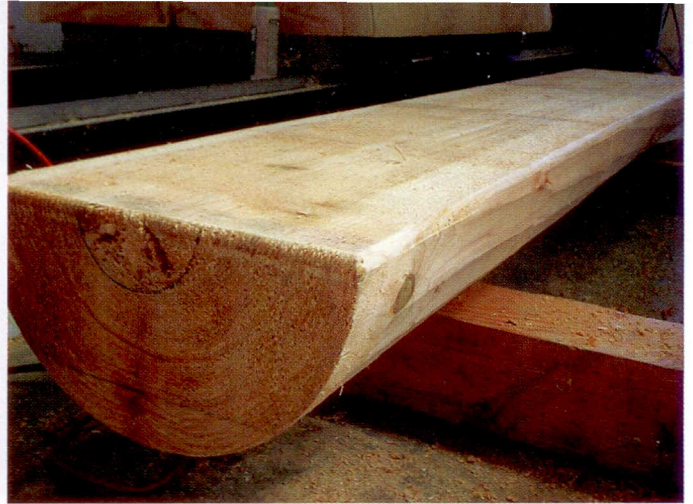
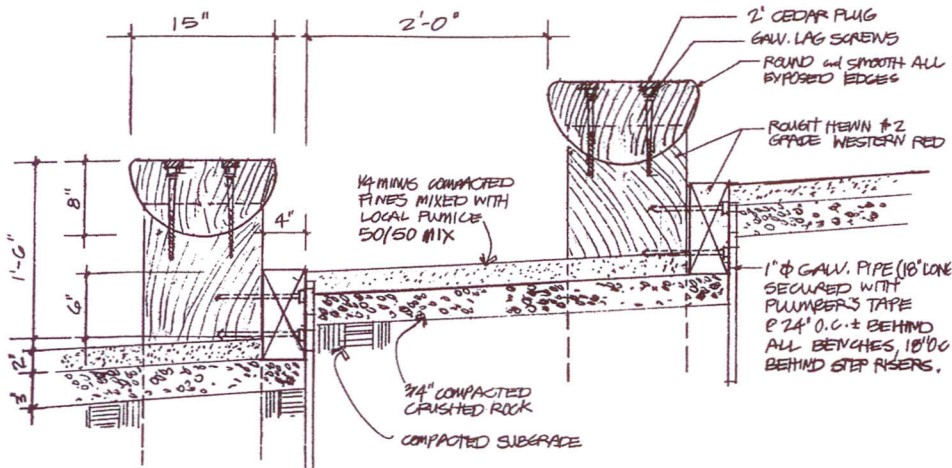
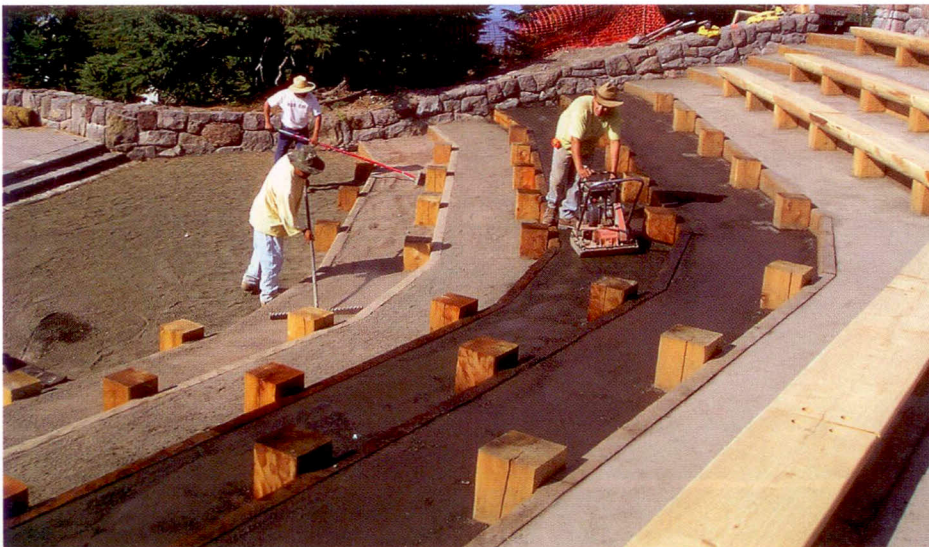
Thirty-foot-long cedar logs were placed on a lathe to be cut into precisely dimensioned rounds, top left. A bench mock-up displays the “draw knife” finish, top right, and the placement of the benches is shown in section, above. Cascadian Landscapers applied a gravel/pumice surface before attaching the benches, below.

turning 30-foot raw logs into precisely dimensioned rounds. Opting for 15-inch-wide benches versus the original 18-inch benches saved nearly \$13,000 in lumber costs. Snow loads of up to 12 feet deep had to be factored in as well, requiring post spacing to not exceed six and a half feet on center. The original post spacing was nearly 10 feet on center, and many benches collapsed after only 10 years of service. The timber supplier introduced us to a “draw knife” finish, a term he used for a process that pulls a series of cutting edges over the log surface and gives it a distinctive “hand-hewn” look.

The cedar rounds were then split down the middle, cut to the bench lengths with a two-inch-deep dado notch below, and matched precisely to each post.
