DETAILS

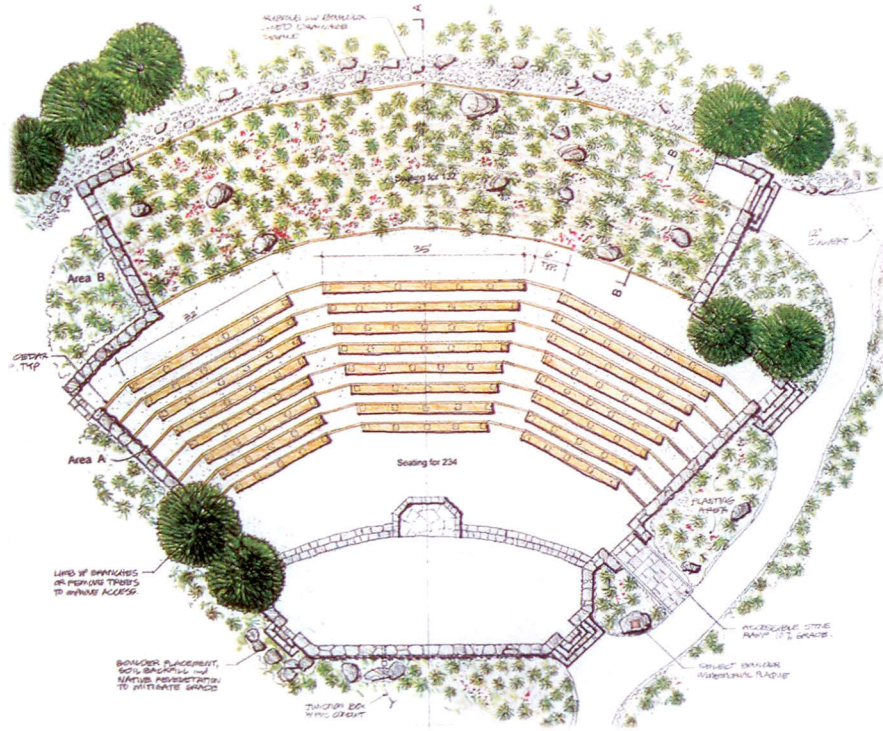
An illustrative site plan shows the new ADA stone ramp to the right of the stage and native plant revegetation proposed for the upper terraces.

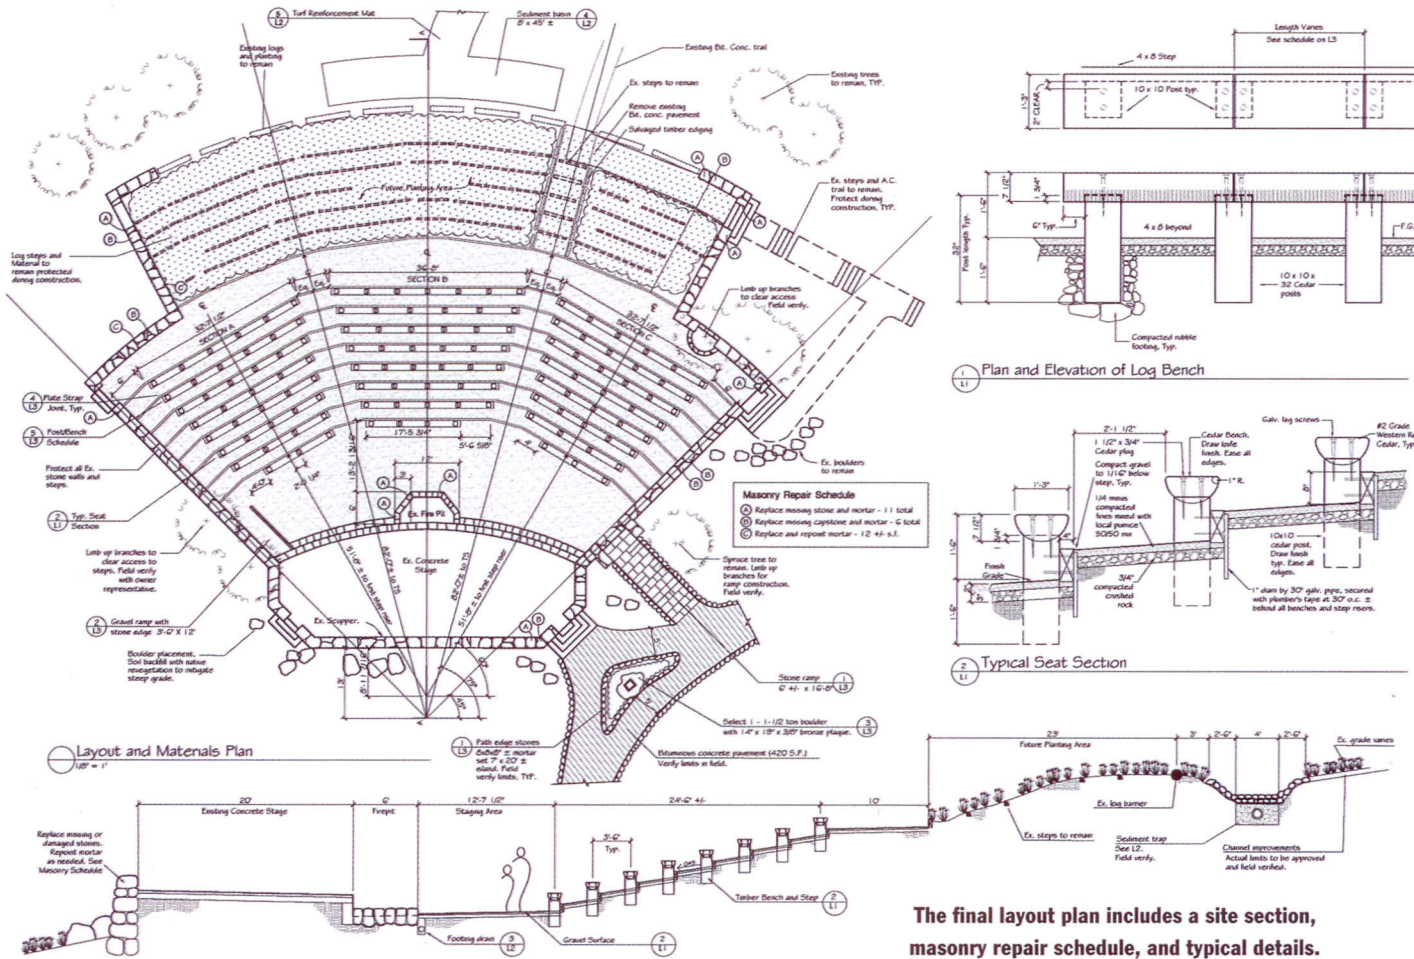
The final layout plan includes a site section, masonry repair schedule, and typical details.
